## Case Report

# Magnetic Resonance and Ultrasound Imaging of Intra-Tendinous Suture Reaction: A Case Series

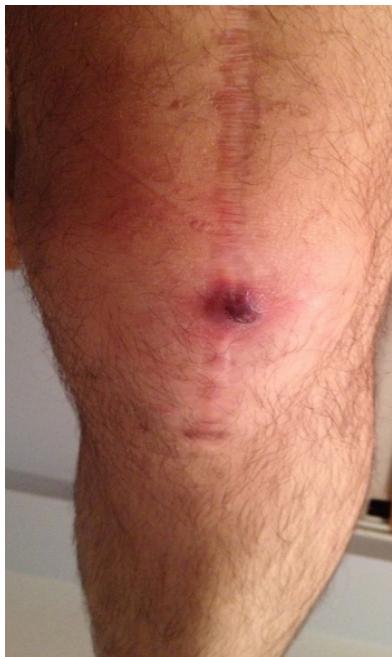
A 34-year-old man presented with an erythematous skin lesion anterior to the patella which occasionally drained bloody and serous fluid (Figure 1).

**Figure 1:** Clinical image of the left knee demonstrating an erythematous skin lesion anterior to the patella embedded within the anterior, midline, surgical scar which would intermittently drain serous material.

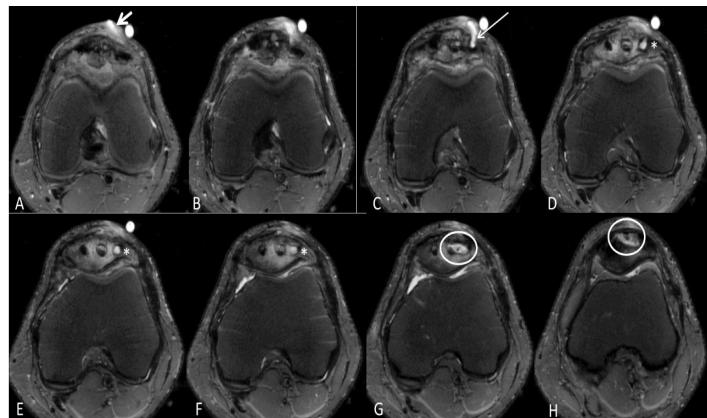
The draining sinus never resolved after surgery and MRI was performed. MRI revealed a sinus tract extending from the lateral patellar tendon suture anchor, coursing through the lateral patellar cortex and proximal patellar tendon, extending into the anterior pre-patellar subcutaneous tissue and skin (Figures 2,3).

**Figure 2:** Axial short tau inversion recovery imaging (A-H) in a 30-year-old man with a draining sinus at the anterior left knee after patellar tendon repair more than 2 years earlier. At the anterolateral skin marker, there is a high T2 signal sinus tract which extends from the skin to the subcutaneous tissues (short arrow, A). The subcutaneous portion of the lesion extends superiorly and posteriorly (B, C) extending through the patellar cortex (long arrow, C) and is continuous with an encysted tract in the lateral patella, consistent with the patient's known suture anchor tract (asterisks D-F). This encysted lateral tract becomes continuous with the central suture anchor tract (oval, G-H), which contains encysted suture material. Note the involved suture anchor track demonstrates increased fluid signal compared to lower signal material within the uninvolved portion of the central suture anchor and the medial suture anchor.

More extensive debridement and resection of the sinus tract was performed 2 months later with removal of remnant suture

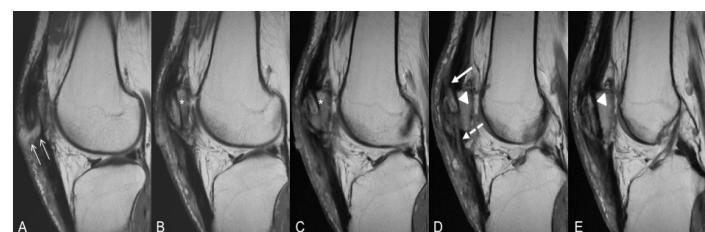
**Figure 3:** Sequential, sagittal intermediate weighted images (A-E) of the left knee for anterior draining sinus after patellar tendon repair. Anterior skin sinus tracks through the pre-patellar subcutaneous tissue and proximal patellar tendon (arrows, A) where it breaches the patellar cortex and is continuous with the lateral patellar tendon suture anchor tract (asterisks, B-C). As seen in Figure 2, the sinus track in the lateral suture anchor tract is contiguous with the central suture anchor tract (arrowheads, D-E). The lateral suture anchor tract has additional sinus tracts extending into the quadriceps tendon superiorly (solid arrow, D) and the more central patellar tendon inferiorly (dashed arrow, D).

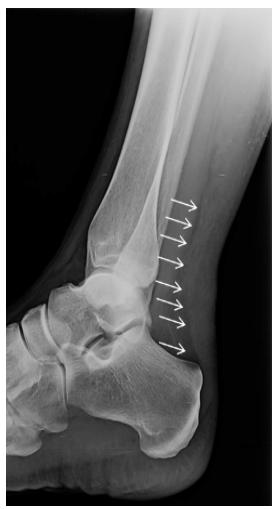
A 52-year-old woman, status post right Achilles tendon repair 2 years prior using #2 coated, synthetic, absorbable, braided suture (Vicryl, Ethicon, Somerville, NJ) and #2 non-absorbable, braided, ethylene terephthalate suture coated with polybutylate (Ethibond, Ethicon, Somerville, NJ), presented with Achilles thickening and tenderness. On physical exam, there was noticeable thickening of the Achilles tendon, without signs of infection or erythema. Ankle radiograph was completed showing extensive longitudinal thickening of the Achilles tendon extending from the site of prior repair (Figure 4).

**Figure 4:** Lateral ankle radiograph in patient 2 demonstrates a diffuse thickened, painful Achilles tendon (arrows) 23 months after surgery.

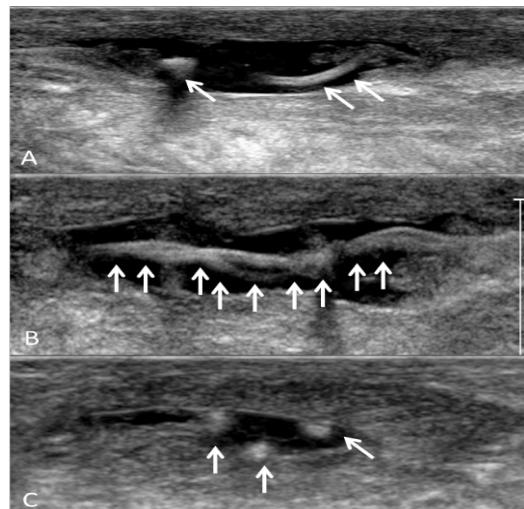
Tendinosis was suspected clinically. Ultrasound was performed for further evaluation of the Achilles and for possible peri-tendinous therapeutic injection. Prior to injection, diagnostic ultrasound revealed a central Achilles, intra-tendinous cyst,

surrounding linear, hyperechoic foci along the long axis of the tendon, consistent with suture material (Figure 5).

**Figure 5:** Longitudinal (A, B) and transverse (C) gray scale ultrasound images of the Achilles tendon in patient 2 demonstrate an irregular-walled cystic structure within the Achilles tendon which contains linear, hyperechoic, looped material, consistent with encysted, longitudinally-oriented, sutures within the tendon substance.

The cyst was percutaneously injected, under sonographic guidance, with 1.5 mL of a 50:50 mixture of 1% lidocaine and 0.25% bupivacaine, which resulted in temporary pain relief. A MRI was recommended by the interpreting radiologist for the evaluation of possible suture reaction. MRI revealed a fluid collection within the substance of the tendon with a cyst surrounding longitudinally oriented, low-signal loops of suture material (Figure 6).

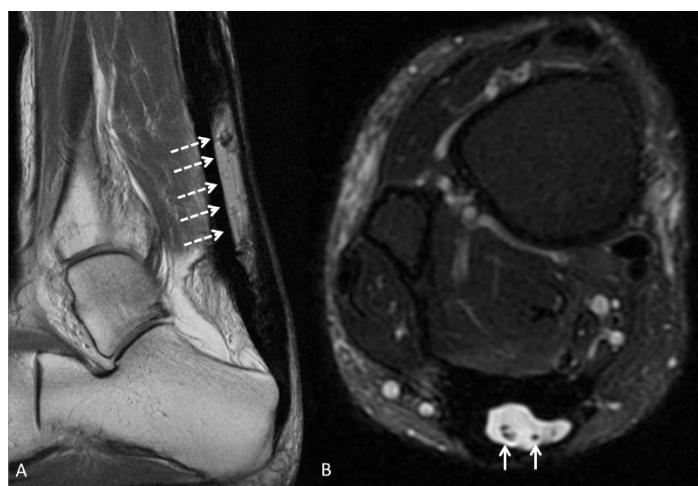
**Figure 6:** Sagittal intermediate weighted (A) and axial T2 weighted with fat saturation (B) images of patient 2 demonstrate a large cystic structure (dashed arrows, A) within the substance of the Achilles tendon in A. Cross-

section of this intra-tendinous cyst in B demonstrates linear, longitudinally oriented foci within the cyst compatible with sutures (arrows, B).

The patient was taken to the operating room, where upon entering the site of prior repair, 10mL of clear fluid was encountered. Suture material was found to be intact but the tendon around it appeared to have liquefied into a cyst. The sutures were easily removed, and the wound was debrided. The tendon was otherwise intact and did not require placement of additional deep sutures. The subcutaneous tissue was closed with 2-0 Vicryl (Ethicon, Somerville, NJ) and skin was closed using 3-0 nylon sutures. Post-operatively, the patient improved but did have multiple instances of Vicryl suture material spitting from the wound. Operative cultures were negative. On follow up two years later, patient continued to have tenderness over the Achilles tendon. An MRI was repeated demonstrating a decreased in size, but persistent intra-tendinous cyst with granulation tissue and fat surrounding residual suture material. A repeat ultrasound was done to look for any residual retained suture material as a cause of the patient's persistent pain (Figure 7).

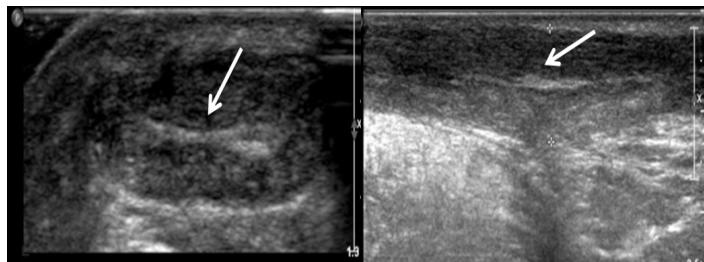
**Figure 7:** Ultrasound of the Achilles tendon. Thickened Achilles tendon with a longitudinally oriented focus of increased echogenicity (arrows) reflected intra-tendinous persistent suture. Resolution of encysted material surrounding the sutures when compared to previous ultrasound.

Ultrasound revealed partial resolution of the intra-tendinous cyst by with inflammatory tissue surrounding the hyperechoic residual suture material. Surgical options were discussed including more extensive debridement as well as the possibility of Achilles tendon reconstruction with allograft. Wound care consultation with a plastic surgeon was also performed. The patient continued with ongoing physical therapy and pain management.

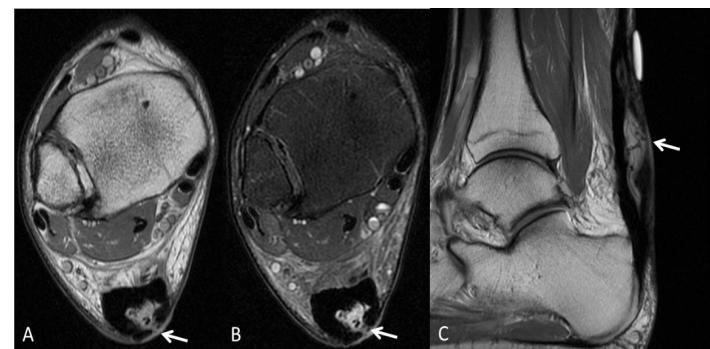
54-year-old male with a history of right Achilles tendon repair in 20 years prior, with unknown suture material, presented with dull pain at the Achilles insertion while training for a marathon. The patient reported no history of trauma. The patient cut down on running, with persistent pain. Over the course of the next few weeks, the patient reported a bump over the posterior ankle, which began to drain purulent material. MR evaluation demonstrated a thickened Achilles tendon, with an intra-tendinous collection which contained linear suture material that was devoid of signal,

suspected to be encysted suture (Figures 7-9).

**Figure 8:** Axial intermediate (A, T2 weighted with fat saturation (B) and sagittal intermediate weighted images of a 52-year-old man with a draining sinus 20 year after Achilles tendon repair. Axial images (A-B) reveal a cystic structure within the Achilles tendon with a focal tendon defect postero-medially consistent with a draining sinus. Punctate foci of low attenuation within the cyst represent encysted non-absorbable sutures. Sagittal intermediate weighted image (C), again reveals an elongated cyst within the substance of the Achilles tendon with a focal rent in the tendon, compatible with the source for draining sinus. Thin, longitudinally oriented, linear foci within the tendon are consistent with encysted non-absorbable sutures from prior repair consistent with a granulomatous reaction.

The patient was taken to the operating room and upon entering the site of prior repair, a large collection was identified

encysting non-absorbable sutures. The sutures were removed in their entirety and the cyst was then debrided down to healthy tissue. The remainder of the Achilles tendon was found to be intact and therefore no deep sutures were placed. The skin containing the draining sinus was sharply excised and re-approximated using 3-0 nylon sutures. Upon follow-up, the patient reported complete resolution of symptoms and returned to full activity within 6 months after surgery. Operative cultures were negative.

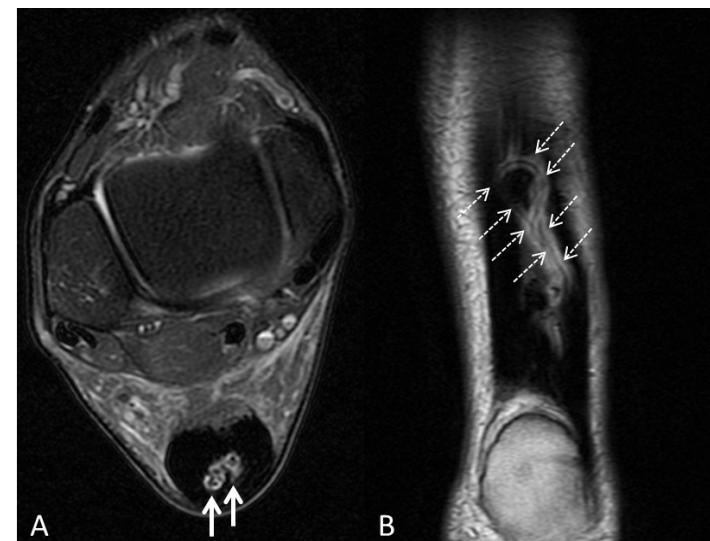
**Figure 9:** Axial T2 weighted fat saturation (A) and coronal intermediate (B) images in patient 3 demonstrate a markedly thickened Achilles tendon status post prior repair. Irregular walled, high fluid sensitive signal, cystic structure is present in A within the Achilles tendon substance containing punctate low signal foci compatible with encysted loops of intratendinous suture material. In B, you can see the longitudinally oriented cyst within the tendon containing looped suture material (arrows).
