Case Report

Breaking Metal and Bone - Multiple Consecutive TKA and DFR Failures in a Cyclist: A Case Report

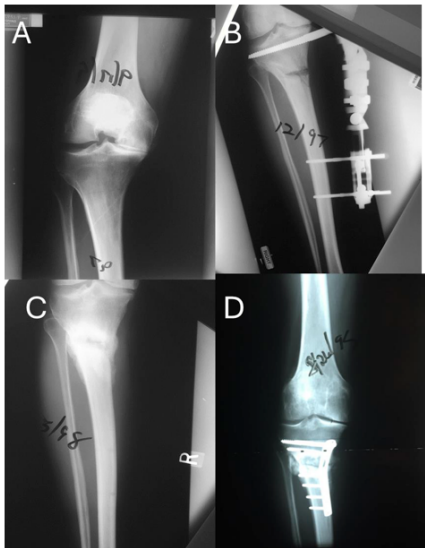
Figure 1: Radiographs of the patient’s initial clinical course, including A) Initial presentation, B) Initial distraction osteotomy, C) Non-union, and D) Non-union plating with bone graft.

In October 1997, the patient presented with varus malalignment of the left knee and underwent a distraction osteotomy in November to achieve 7° of valgus. Post-operatively, he achieved painless full weight-bearing with an external fixator. After its removal, he walked full weight-bearing. In August 1998, the patient experienced increased pain and was found to have a hypertrophic nonunion at the osteotomy site, leading to further plating and bone grafting (Figure 1). The patient was lost to follow-up and did not return until 2006. Imaging revealed a healed malunion, resulting in internal rotation of the distal tibia at the osteotomy site (Figure 2).

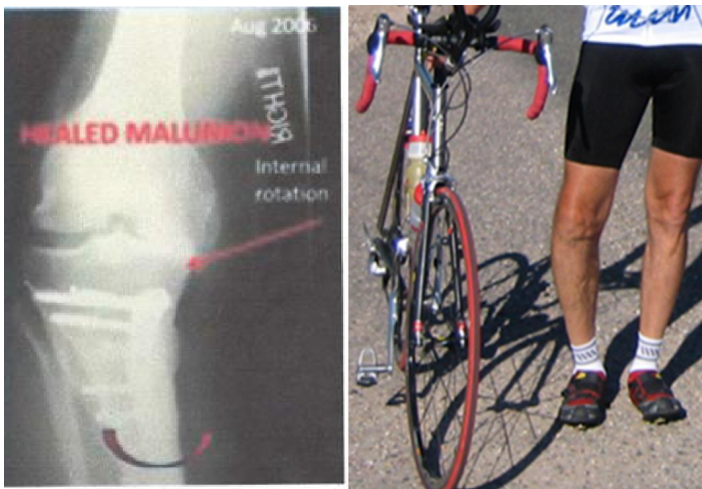
Figure 2: Plain radiograph depicting the site of healed malunion in the right tibia following plating and bone grafting, now with internal rotation present, as well as pictures of the knee with rotational deformity. The internal rotation depicted developed over a period of 9 years.

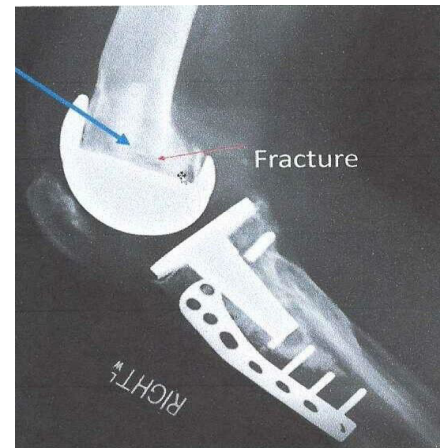
Figure 3: Plain radiograph depicting a distal femoral fracture proximal to the bone-implant interface following an unstemmed TKA.

Evaluation in 2006 resulted in a decision that a repeat tibial osteotomy would not be feasible due to the encasement of the popliteal artery in scar tissue. He was referred to an arthroplasty specialist for a primary total knee arthroplasty (TKA) due to difficulty balancing the ligaments and correcting the coronal alignment. This procedure was performed using a Stemmed Rotating Platform (MBT) tibial component and a Sigma RP posterior-stabilized femoral component. After 12 weeks of physical therapy and a painless gait, the patient was allowed to ride his bicycle following evaluation by his surgeon at the three-month mark postoperatively. Notably, the patient is an avid long-distance cyclist, and he stated that he had already been riding his bike and was feeling great. In January 2010, he had been going to a rheumatologist on his own and was having repeated aspirations of hemarthrosis. After being consulted by this rheumatologist, the patient returned to the surgeon's clinic in February 2010 with knee pain. Radiographs illustrated loosening and possible periprosthetic fracturing at the very distal femur with radiographic separation of cement from the

bone without loosening at the bone-implant interface (Figure 3). The surgeon felt the hemarthrosis was a result of bleeding from the femur marrow, and there was a periprosthetic fracture.

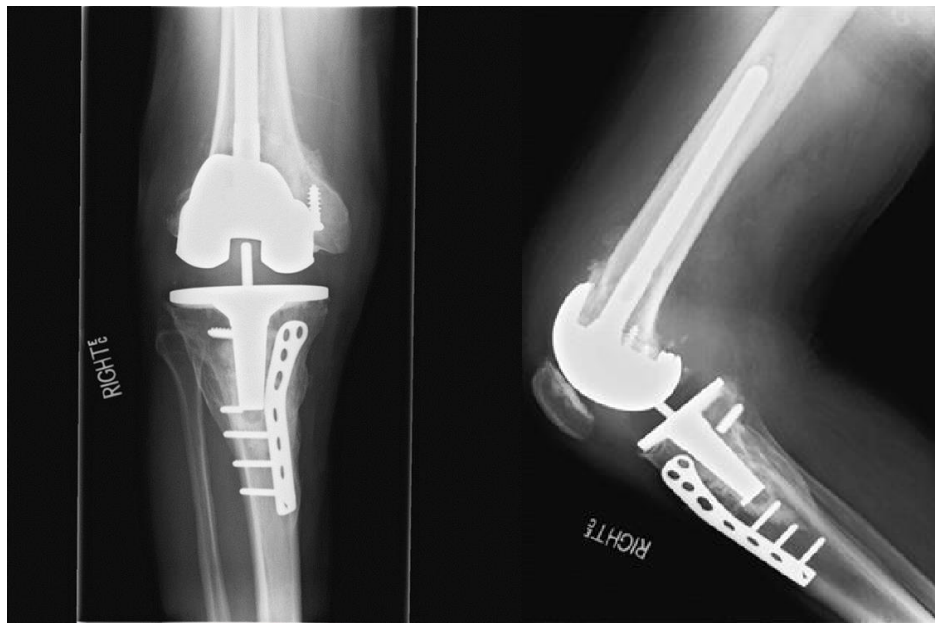
Figure 4: Initial post-operative films of first revision TKA.

After the failure of the primary total knee arthroplasty (TKA), a revision TKA (rTKA) in February 2010 was performed, utilizing a stemmed TC3 femoral component, and reinforced with rebar (Reinforced bars), given the Distal Femoral Fracture (DFF) that caused the initial failure (Figure 4). The rebar enforcement has been used numerous times by the attending physician. Rebar is commonly used to strengthen cement on roads. The attending used screws, impacted cancellous bone with bone cement to rebuild defects at interfaces in rTKA. The literature has validated it to improve the implant's strength and stability [4,5]. Postoperatively, the patient felt well and returned to his daily activities, which included resuming competitive cycling shortly after the operation. The patient had no complaints of pain. However, almost 25 weeks later, the patient returned with reports of debilitating knee pain. Plain radiographs revealed that the patient had again undergone a DFF with additional breakage of the locking bolt in the femoral stem component (Figures 5 and 6). Between the first rTKA and failure, the patient reported daily cycling, equating to distances of over 100 miles per week.

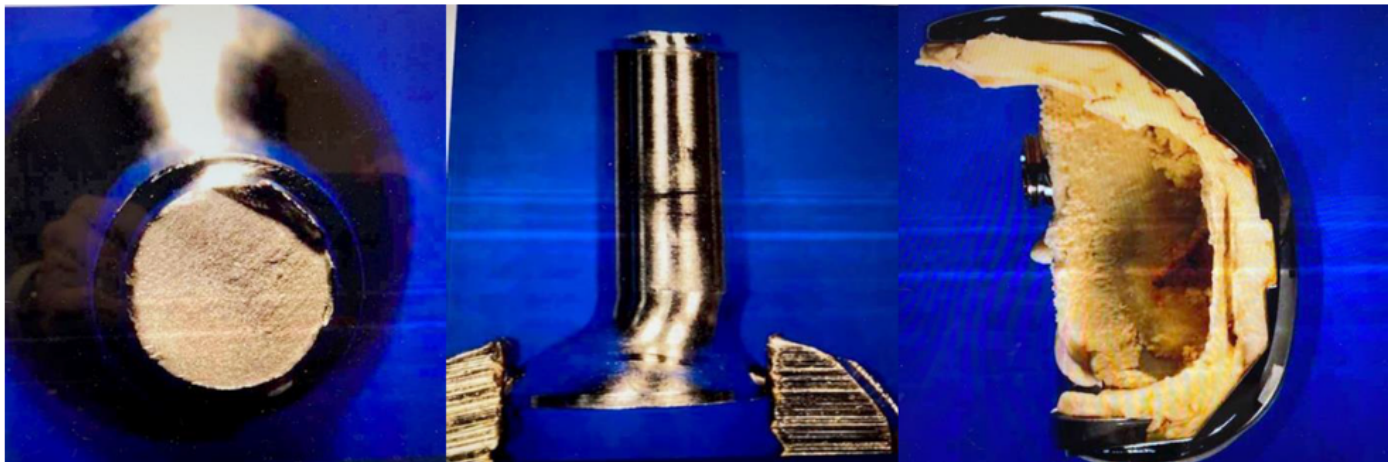
Figure 5: Broken cemented screw in the femoral component. Notice that the distal bone and cement firmly adhered to the femoral component, indicating there was no loosening but a distal fracture.

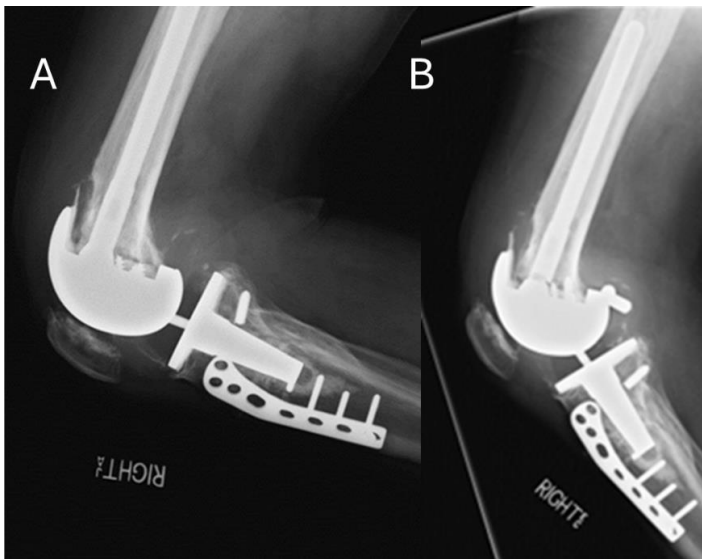
Figure 6: A) Plain radiograph depicting integrity of the TKA revision with stem 24 weeks post-op. B) Plain radiograph showing a distal femoral fracture near the bone-implant interface and subsequent cement bolt failure just 5 days after the 24-week post-op radiograph.

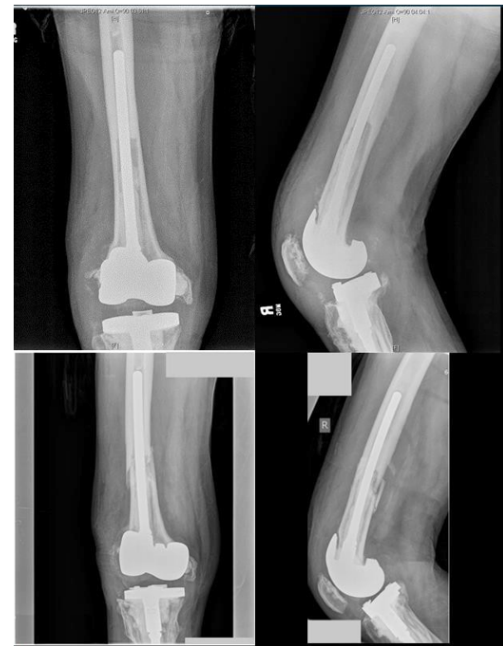
Figure 7: Plain radiograph depicting post-operative pre and post-mid-shaft femoral fracture around the stem implant from TKA revision.

The patient was then referred to another surgeon who used a different brand of revision implant and a component with a larger diameter and robust stem. The patient underwent a second rTKA at an outside hospital and received a Vanguard SSK Constrained Knee, which was constrained in a cast for 4 weeks to ensure varus-valgus alignment. 7 weeks post-op, the patient returned for manipulation under anesthesia for arthrofibrosis and 16 weeks later was found to have incurred a femoral fracture along the stem of the femoral TKA component (Figure 7). The patient was told to refrain from cycling. The patient reported again, however, having returned to competitive cycling following cast removal and, after 16 weeks, started to have severe pain.

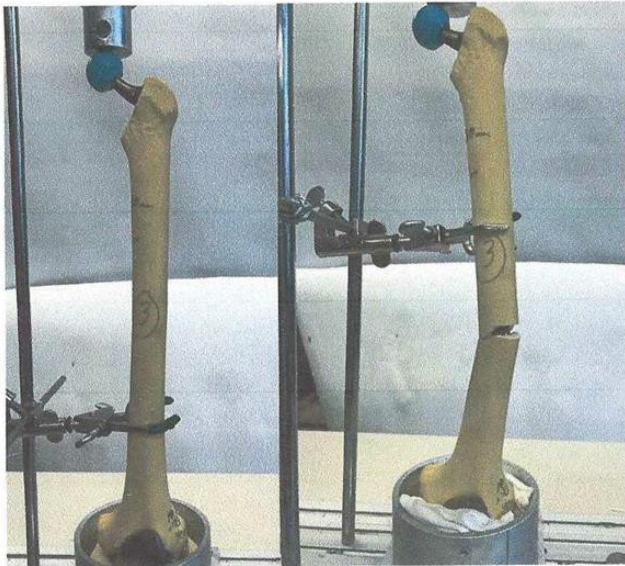
Figure 8: Saw-bone model with peri-prosthetics placed under axial load demonstrated mid-shaft fracturing at 1236.68 N of force.

The fracture leading to phase 4 surgery was unlikely and not due to periprosthetic malfunction or operative error. The patient's cycling, despite physician advice, likely produced the forces needed to fracture the femur around the stem implant. Previous studies have shown that cyclists weighing 60 kg experience a compressive force of 700-800 N in the tibiofemoral joint during pedaling, with a maximum of 910 N during a hill-climbing stance. [6,7] However, these forces alone are insufficient to fracture the femur. In a biomechanical experiment on sawbone models at the University of Illinois at Chicago, 1236.68 N was required to fracture the femur, approximately 55% more than seated pedaling and 36% more than hill climbing (Figure 8). The patient's prior malunion, causing internal rotation of the distal tibia, added rotational forces that contributed to the fracture.

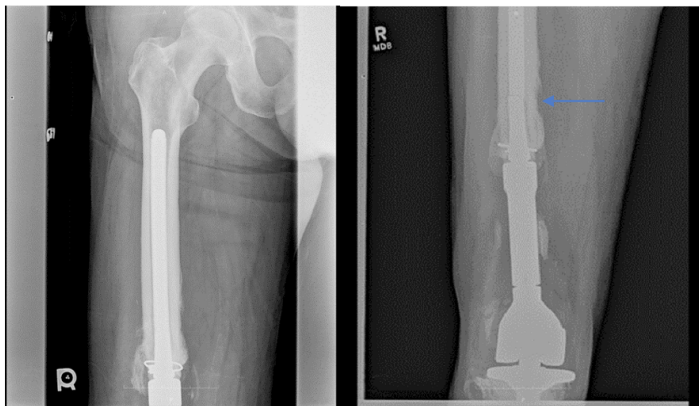
Figure 9: Plain radiograph depicting AP of post-operative DFR and subsequent mid-stem fracturing at the site of the blue indicator.

After the second rTKA failed, a DFR with a hinge was pursued at the outside hospital (OSH). The patient was advised not to exercise aggressively with this new implant, yet he continued to participate in competitive cycling. After six weeks, the patient returned for evaluation of leg pain, and it was discovered that the DFR had broken along the proximal metal stem (Figure 9).

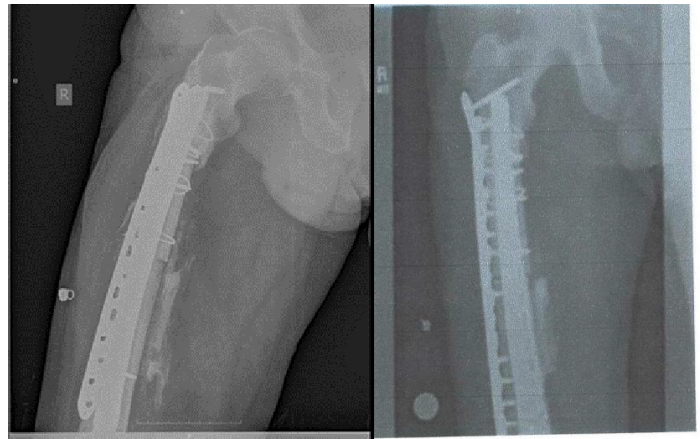
Figure 10: The last available imaging from this patient shows a plain radiograph of a distal femoral replacement revision with a locking plate. The screws in the locking plate had been broken off. They unscrewed, as shown in this image, with an additional nonunion implant failure.

The femoral component of the DFR was replaced and reinforced with a femoral fracture plate with an allograft. After 12 weeks, the

patient returned to the OSH and was found to have had nonunion of the proximal femoral osteotomy. Further imaging evaluation also revealed that the patient had unscrewed screws in the femoral plate construct, while also breaking the allograft, some other screws, and the plate itself (Figure 10).
